The investigation of dissolution subsidence incorporating microgravity geophysics at Ripon, Yorkshire

D. A. Patterson,¹ J. C. Davey,² A. H. Cooper,³ & J. K. Ferris⁴

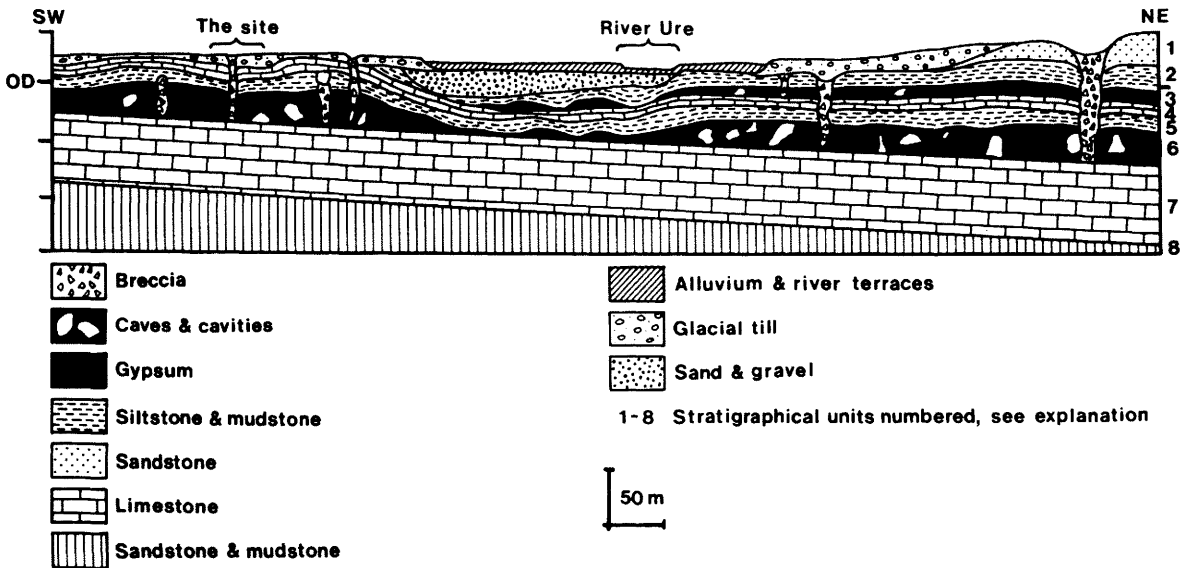
FIG. 1. SW-NE cross section through the Ripon site and across the River Ure, slightly stylized but based on about 20 boreholes in the vicinity. 1, Sherwood Sandstone Group; 2, Roxby Formation; 3, Gypsum in the Roxby Formation; 4, Brotherton Formation; 5, Edlington Formation; 6, Gypsum in the Edlington Formation; 7, Cadeby Formation; 8, Carboniferous strata. Also illustrated is the development of caves in the gypsum sequences and their upward propagation as breccia pipes. Numerous ages of breccia pipes are shown, some filled with glacial deposits, others only recently breaking the surface.

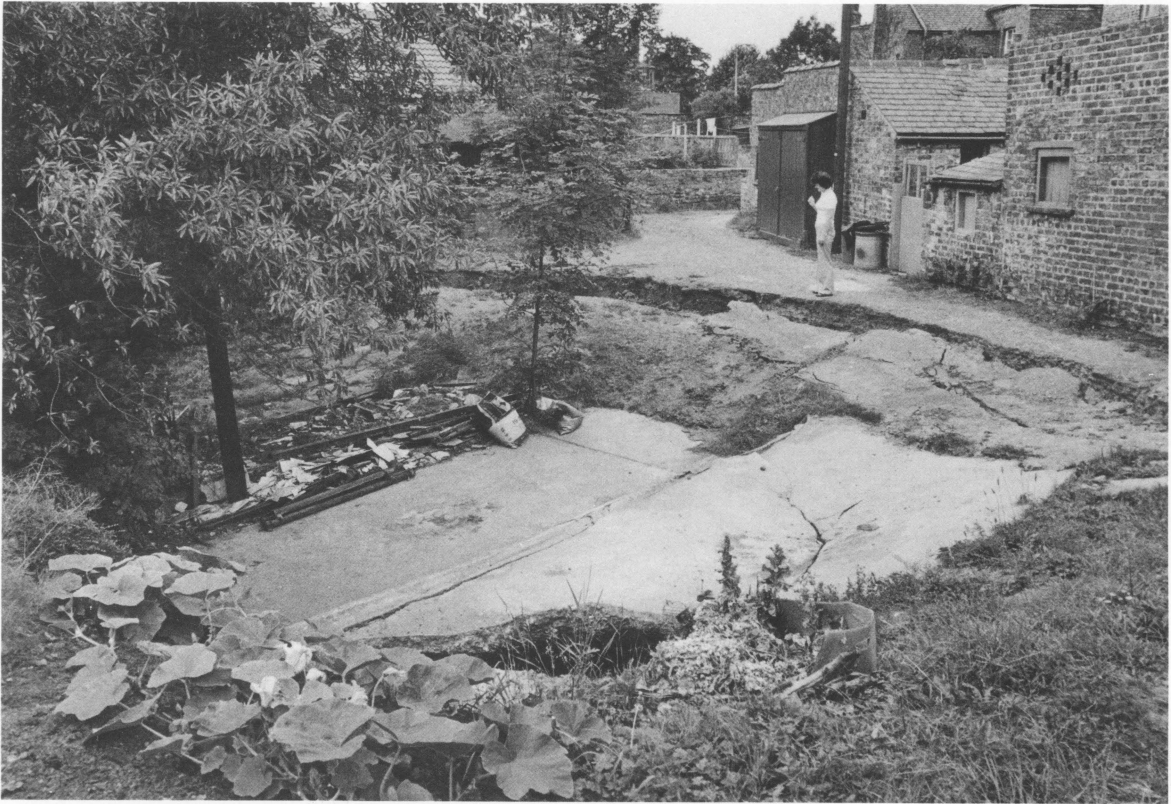
Such conditions have resulted in the collapse of numerous buildings around the city and much of the housing stock has suffered various degrees of distress (Fig. 2) (Griffin 1986). In the past the worst areas have been largely avoided but modern pressures on land require more of the difficult areas to be considered for future development (Harrogate Borough Council 1992).

FIG. 2. Subsidence hollow formed on 28th July 1979 behind houses on Magdalen's Road, Ripon (SE 3170 7129), 200 m SE of the site discussed. The garages which stood on the concrete slab had long shown signs of distress and were demolished prior to this catastrophic collapse (photo: Acrill Newspapers).

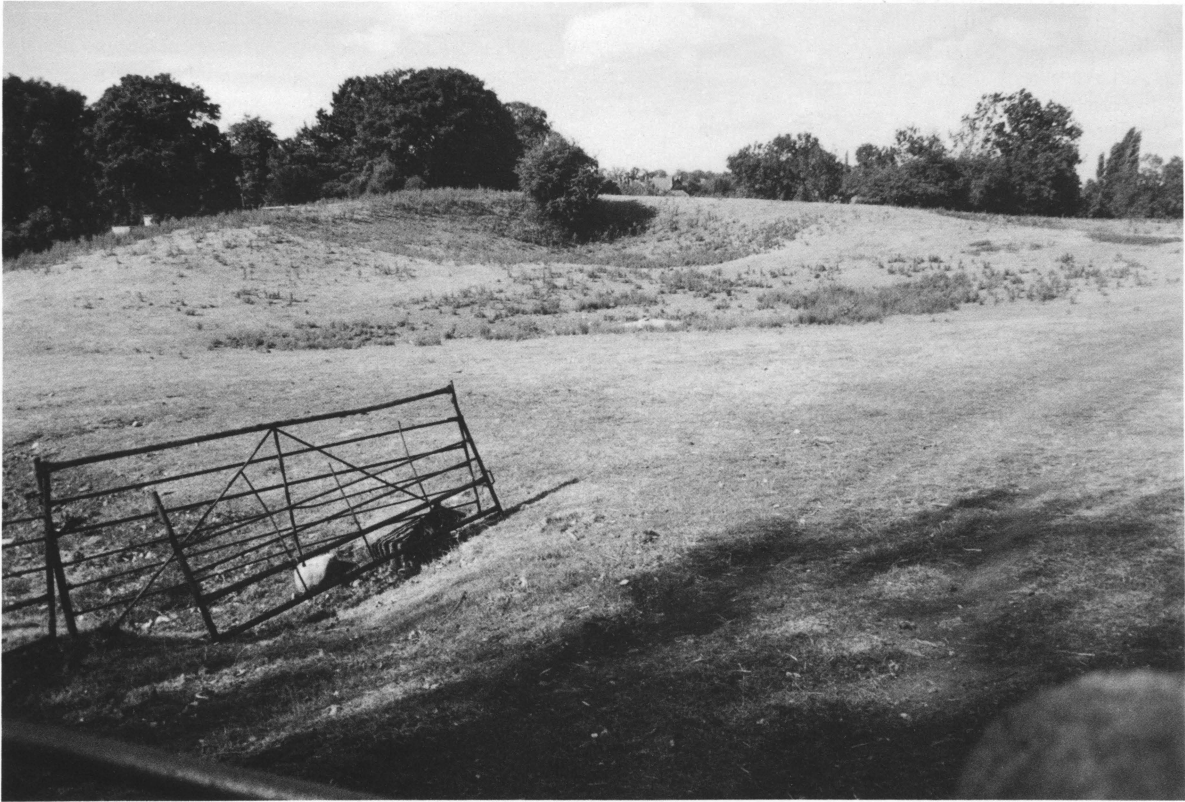
FIG. 4. Subsidence hollows on the greenfield site on the A61 North Road.

green field site of some 8000 m² alongside the A61 North Road. For initial assessment, a literature and plan search was undertaken together with a brief walkover survey. What were believed to be subsidence hollows were visible in the centre of the site (Fig. 4) and just beyond the northern site boundary. The same features were shown both on the First Edition Ordnance Survey maps of 1982 and on the recent airborne study (Cooper 1989).

Two existing borehole records confirmed the ground depression within the site to be the result of subsidence. One borehole located within the feature revealed about 9 m of soft clay and peat underlain by badly broken limestone, dolomite, gypsum and calcareous mudstone. Below 30 m to the base of the borehole at 35 m, relatively intact dolomitic limestone was reported. However, it was believed that unless the geological map was incorrect, this apparently competent stratum was gypsum rather than limestone. In the second borehole, located away from any obvious subsidence feature, a sequence of essentially granular glacial deposits extended to a depth of 12 m, where it was underlain by weathered and badly broken strata, again described as dolomitic limestones. In both boreholes, rotary and open hole techniques had

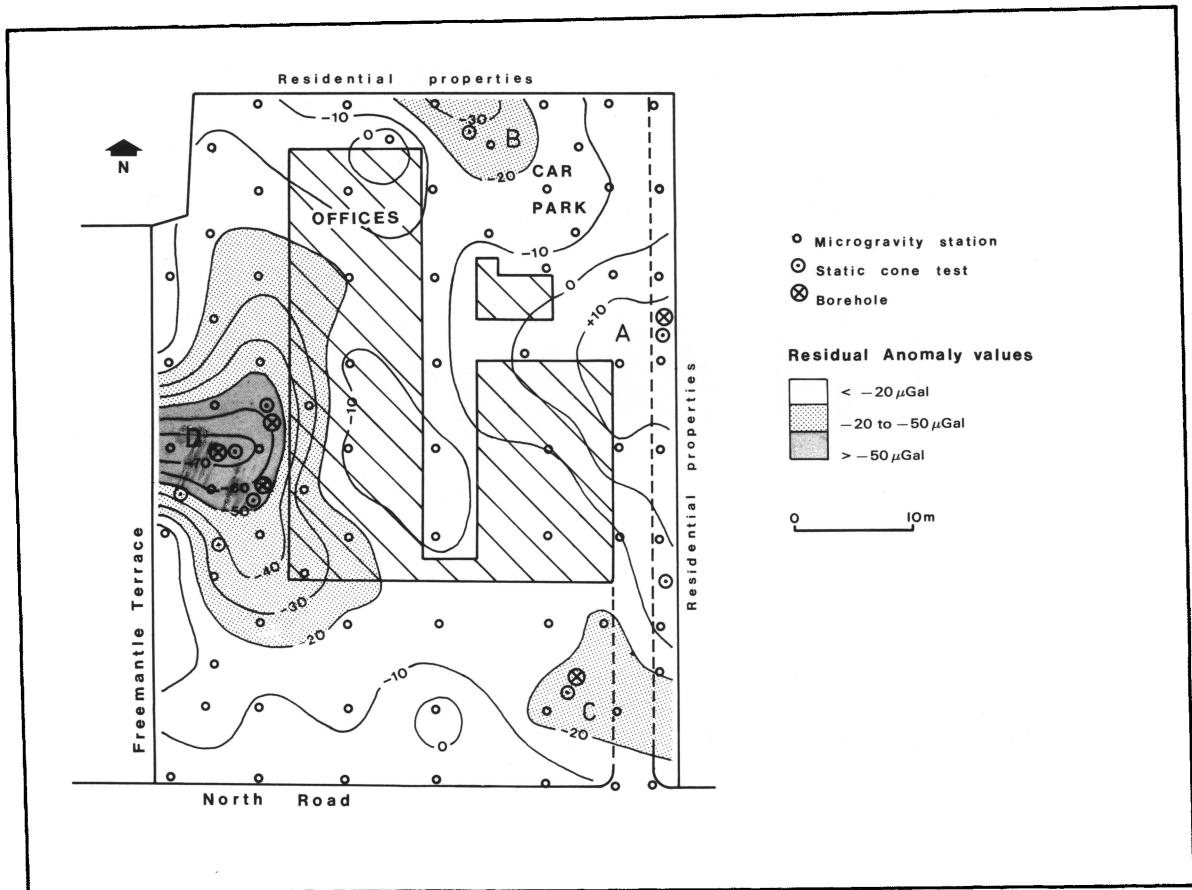
Over most of the site, residual gravity values fell within the range -20 to $+20 \mu\text{Gal}$ and as in Area A on Fig. 5, commonly reflect generally stable conditions. In addition, there were three areas of more negative values, where less dense ground could be expected. In two of these, Areas B and C to the north and southeast of the

FIG. 5. Plan of the redevelopment site showing the microgravity results, core penetrometer test and borehole locations.

site, values dropped to $-30 \mu\text{Gal}$ and, whilst possibly indicating some disturbed ground or an increase in post-glacial cover, the anomalies were not thought to indicate that extraordinary engineering problems would be met. They may have represented the extremities of more significant anomalies located beyond the site boundaries. The third, and largest, of these negative zones, on the west side of the site (Area D on Fig. 5), gave values below $-40 \mu\text{Gal}$ over a broad area, dropping to $-74 \mu\text{Gal}$ in the centre of the anomaly. Preliminary gravity modelling suggested a reduction in density by as much as 0.5 g/cm^3 in the central 5m or so.

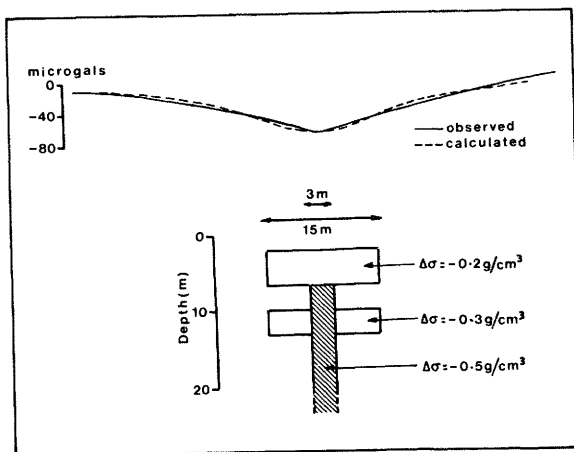
FIG. 6. Basic gravity model used to interpret the observed residual anomaly, proved by subsequent physical investigation to be substantially correct.

Figure 6 illustrates a more complex model, where selected features are modelled in three dimensions, made after drilling and prior to trenching.

40 m of loose sands, silts, and clays with some organic material and occasional gravels. The lack of any surface expression of this feature was explained by the presence of up to 3 m of fill material. The gravity model (Fig. 7) postulated for the structure was shown to be substantially correct.

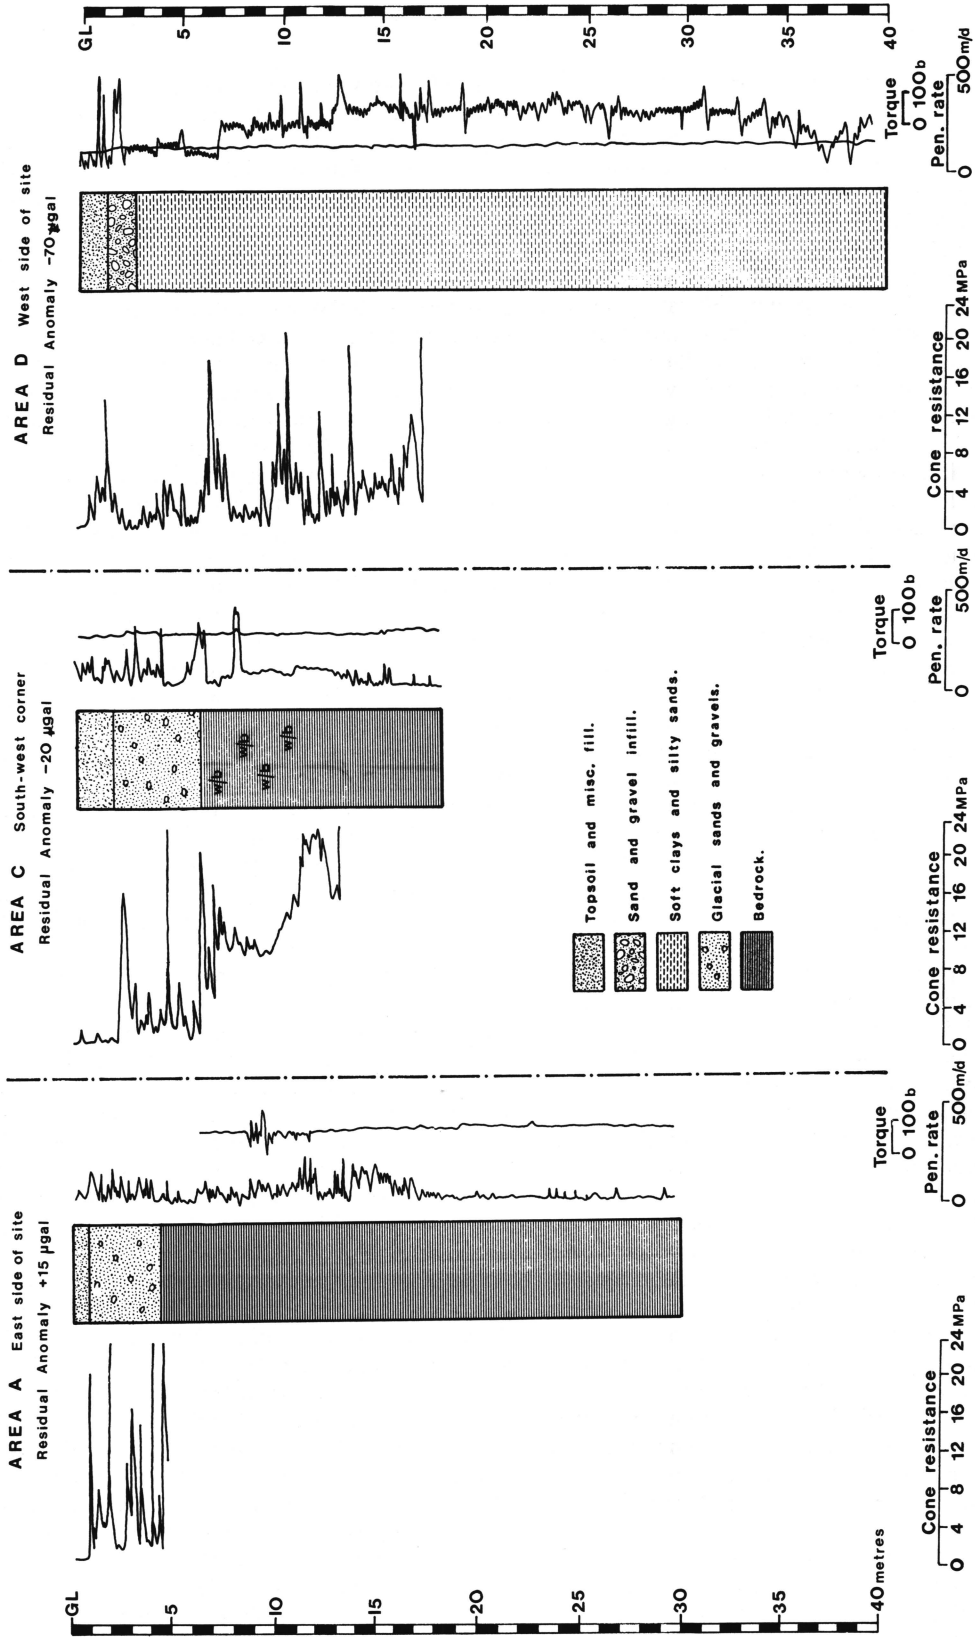
FIG. 7. Geological logs together with CPT drilling torque and rate of penetration results for selected areas within the redevelopment site.

The results of the static cone and drilling investigations (Fig. 6) confirmed that the geology of the site generally conformed to the published stratigraphy of the area and that the location and dimensions of anomalies had been well defined by the microgravity survey.

Beneath the typically thin topsoil and some 1.7 m of assorted fill, the glacial drift comprised loose, becoming dense, sands and gravels with some gravelly sands and firm to stiff sandy silty clays. Most of the static cone tests met with refusal at less than 9 m depth within the drift deposits in very dense or hard material; this may be associated with localized secondary calcitic cementation, as suggested by other investigations in the area, and/or with an increase in particle size. These refusals included four of the five tests undertaken in the area of the major microgravity anomaly. Had the investigation ceased here and without the benefit of previous geophysics, this anomalous feature is unlikely to have received further attention.

The majority of boreholes drilled encountered limestone bedrock at depths of 11.5 to 13.6 m. This was generally moderately strong to strong but frequently contained clay partings or weak marl bands. Whereas most boreholes were taken to a depth sufficient to prove a thickness of limestone between 2.5 and 4.9 m, the control borehole on the eastern site boundary was drilled to a depth of 30 m. The LWD data suggested that marls occurred below 26.4 m, making the Brotherton Limestone Formation at this location 14.4 m thick. This roughly accords with its thickness proved locally in cored boreholes.

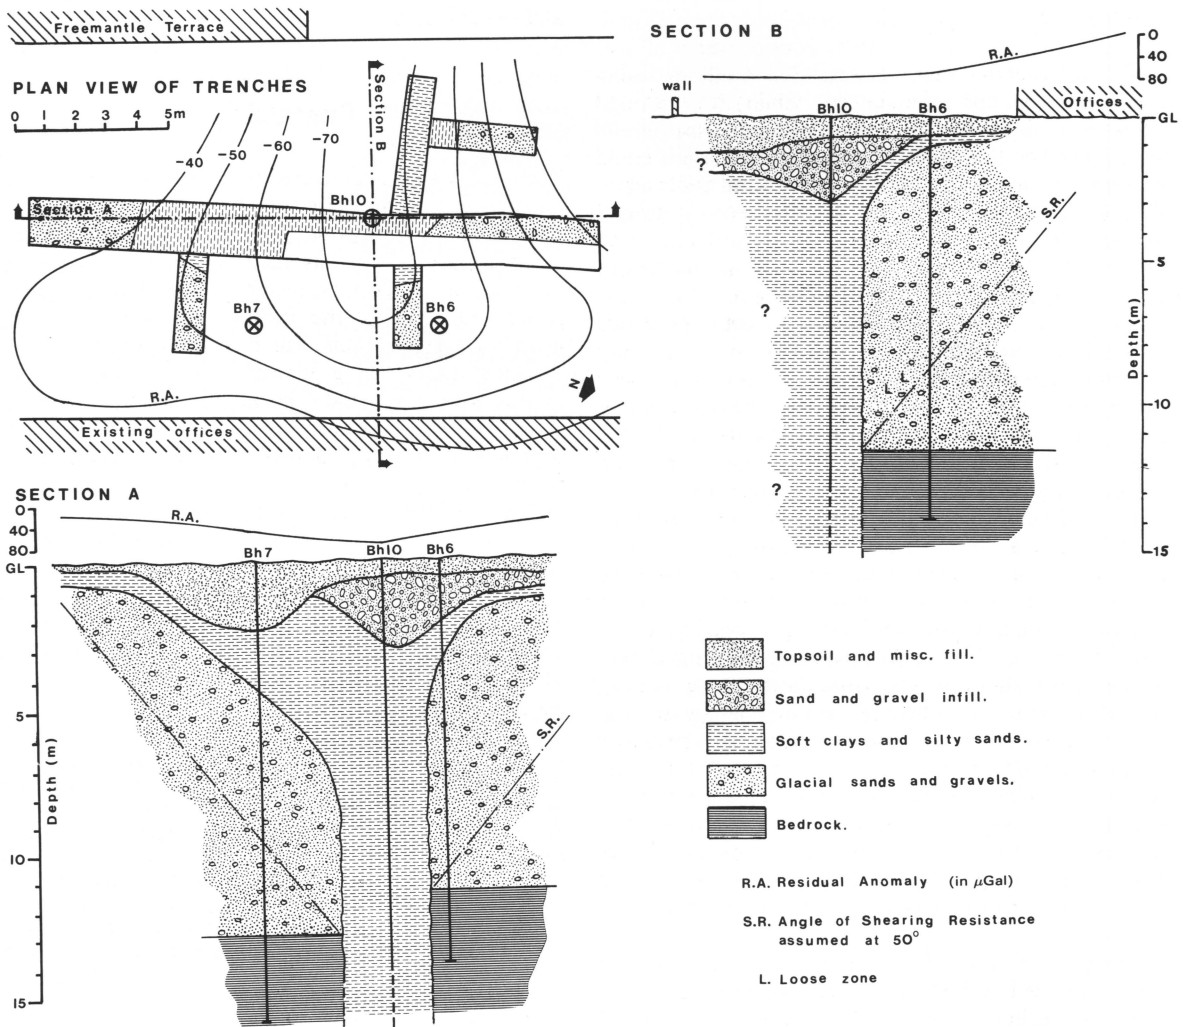
Investigation was completed by trenching across this area in order to obtain additional information on near-surface conditions, collapse geometry, and recent subsidence history. The composite profile of this feature derived from this exercise is shown in Fig. 8. The feature was found to comprise a relatively narrow collapse 'pipe' within a larger depression in the normal near-surface succession which itself had become infilled with alluvial and fill materials. The pipe was shown to be no more than about 3 m in width along its north-south axis but at least 6 m wide along its east-west axis and may well extend beyond the site to the rear of Freemantle Terrace as did the near-surface hollow. Such an east-west orientation characterizes many of the dissolution features in the Ripon area (Cooper 1986).

The distribution and composition of the fill materials in the uppermost 3 m of the feature revealed its recent subsidence history. Almost directly above the 'pipe' was an inverted cone infilled with clean well graded sand and gravel hardcore. The interface between this and the underlying laminated clays and silts was only slightly weathered and had a uniform slope angle of 20°. The lamination of the clays and silts tended to parallel the interface. Above the hardcore and around its margins an assortment of building rubble was mixed with the near-surface alluvial and drift material.

From this and a knowledge of the recent history of the area, it has been postulated that development work some 50 years ago for the existing offices caused up to 3 m of rapid settlement within the collapse pipe which was backfilled with hardcore at that time. Since there is no buried topsoil, it appears that the site was stripped to a shallow depth before this settlement. Indeed, it is likely that collapse was propagated by construction traffic vibration and/or surcharge loading. There is no evidence of any significant movement since infilling and re-levelling. It is believed that the pipe and the broader subsidence hollow are old features which had effectively reached a state of equilibrium in the latter stages of alluvial infilling but had become de-stabilized during

FIG. 8. Results of the trenching exercise across the subsidence feature identified on the redevelopment site.

construction of the existing building. Further collapse during future redevelopment would be entirely feasible.

The redevelopment strategy adopted, and suggested for other similar sites, has been principally to consider a minimum impact scheme with the aim of placing the structure in an area currently considered to be stable and to adopt a shallow foundation design imposing a low ground-bearing pressure. It has to be recognized that through alteration of the groundwater flow regime, caused by external influences as well as by natural changes, there is a finite time over which any given site within a subsidence-prone area may remain stable. In an attempt to safeguard against such changes, an element of rigidity, e.g. reinforcement to allow the foundation to span or cantilever over a settlement feature which may develop, and the possible inclusion of jacking points to allow re-levelling may be incorporated in the foundation design.
